# VEHICLE INSPECTION REPORT

**DY18JHH**

## Volvo FH

VIN YV2RT40CXJB872083

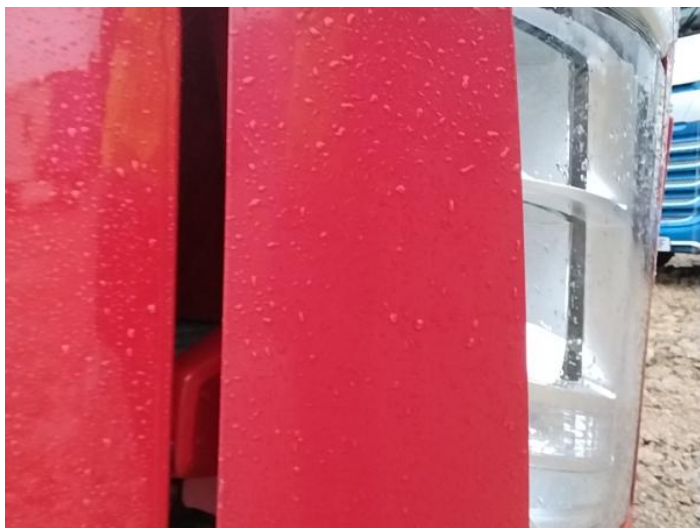
1: Fog Lamp Surround os  
Scratched (Painted)  
UpTo 25mm Thru Paint

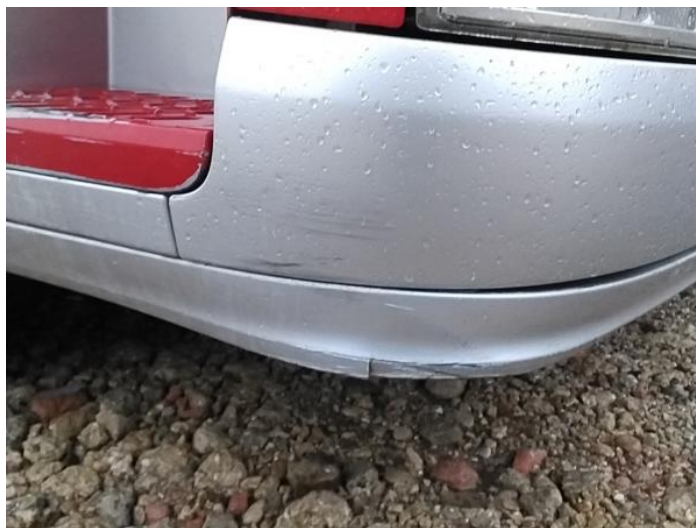
2: Bumper Front Moulding  
Scratched (Painted)  
UpTo 25mm Thru Paint

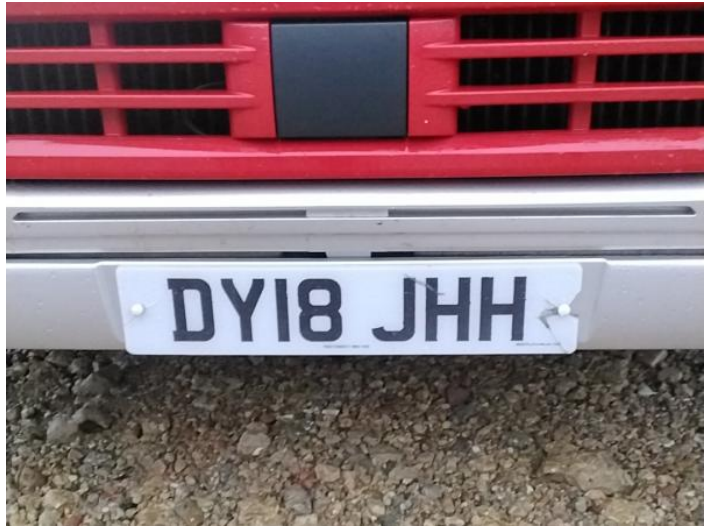
4: Number Plate Front  
Broken  
Replace

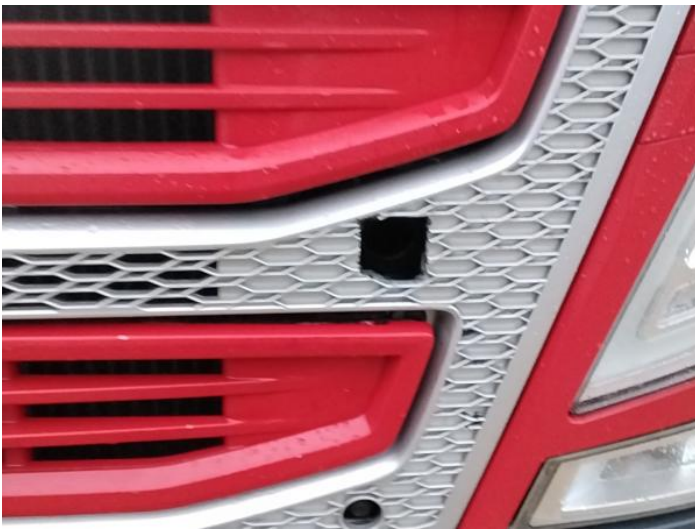
5: Front TowEye Cvr  
Missing  
Replace

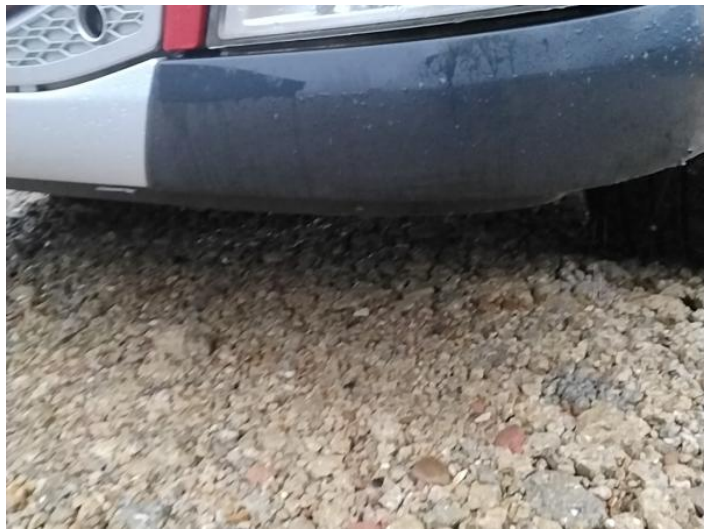
6: Bumper Front Moulding  
Missing  
Replace

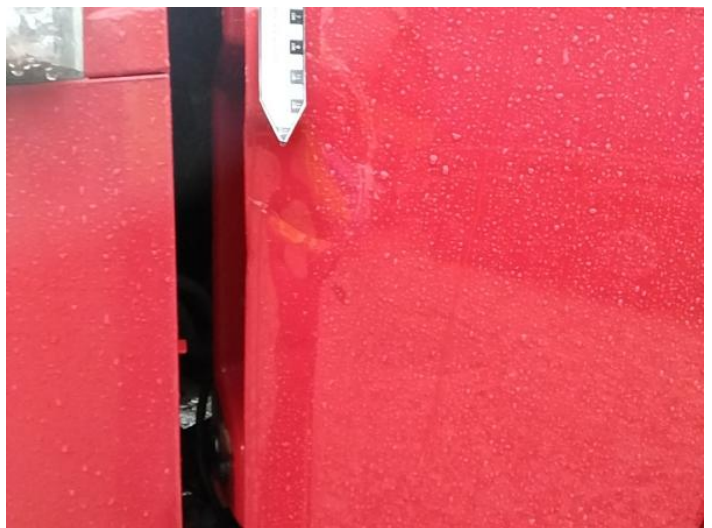
8: Door nsf  
Dented  
With Paint Damage

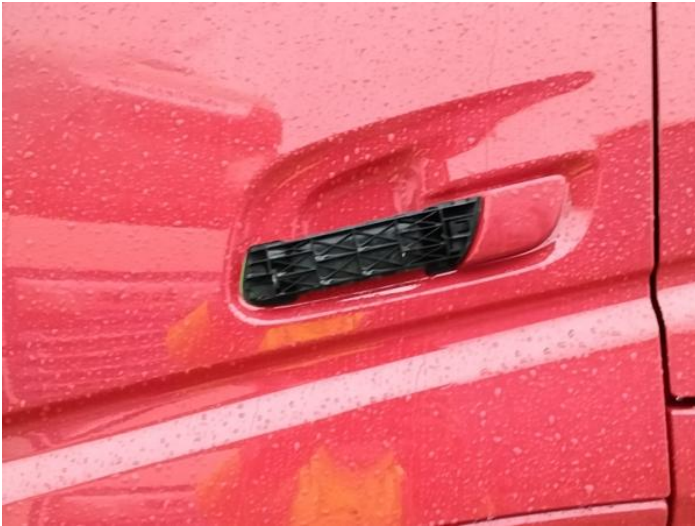
9: Handle Outer nsf  
Broken  
Replace

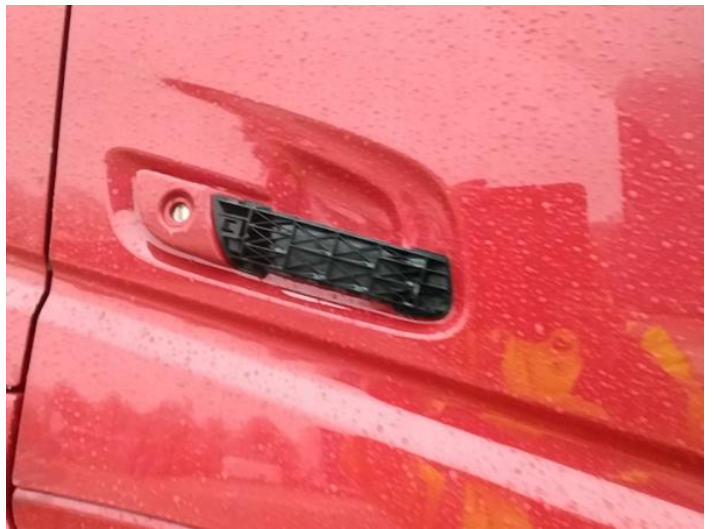
12: Handle Outer osf  
Missing  
Replace

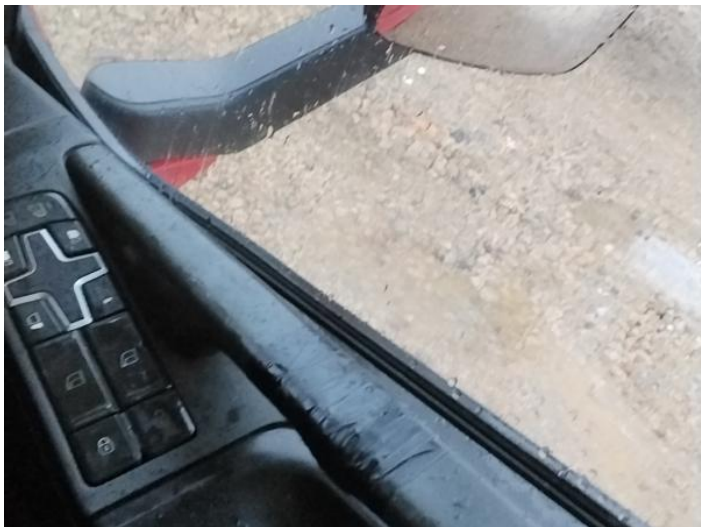
15: Handle Inner osf  
 Damaged  
 Replace
